**CALSPAN ON-SITE SCHOOL BUS/PEDESTRIAN ACCIDENT INVESTIGATION**

**CALSPAN CASE NO. 95-6**

**SCHOOL BUS: 1989 BLUE BIRD TYPE D BODY**

Preliminary Prints  
Calspan Case No. 95-6

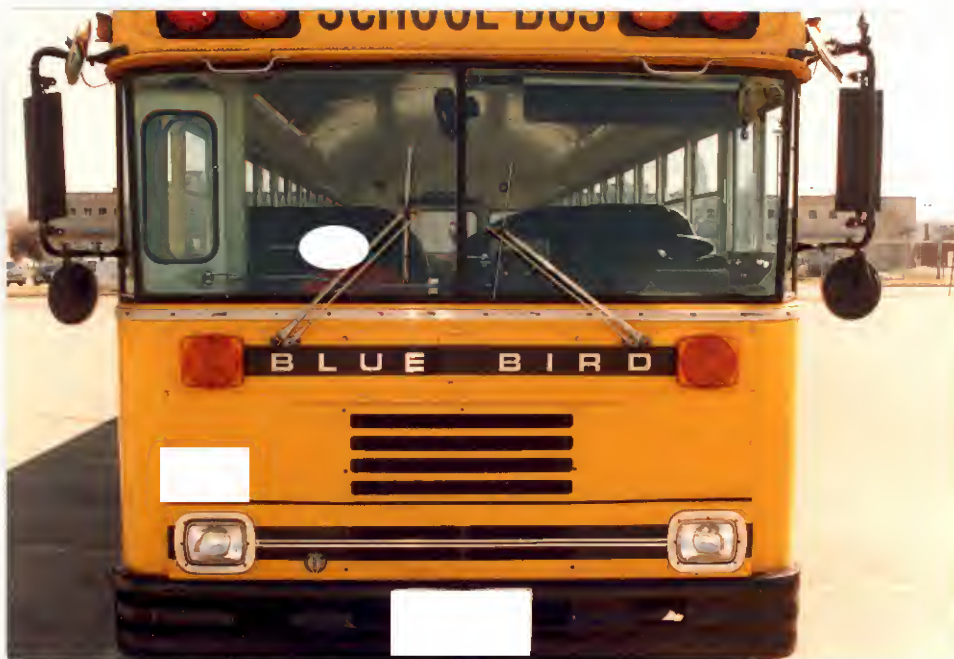
1. View of the frontal plane of the Type D (Forward Control) School Bus manufactured by Blue Bird.

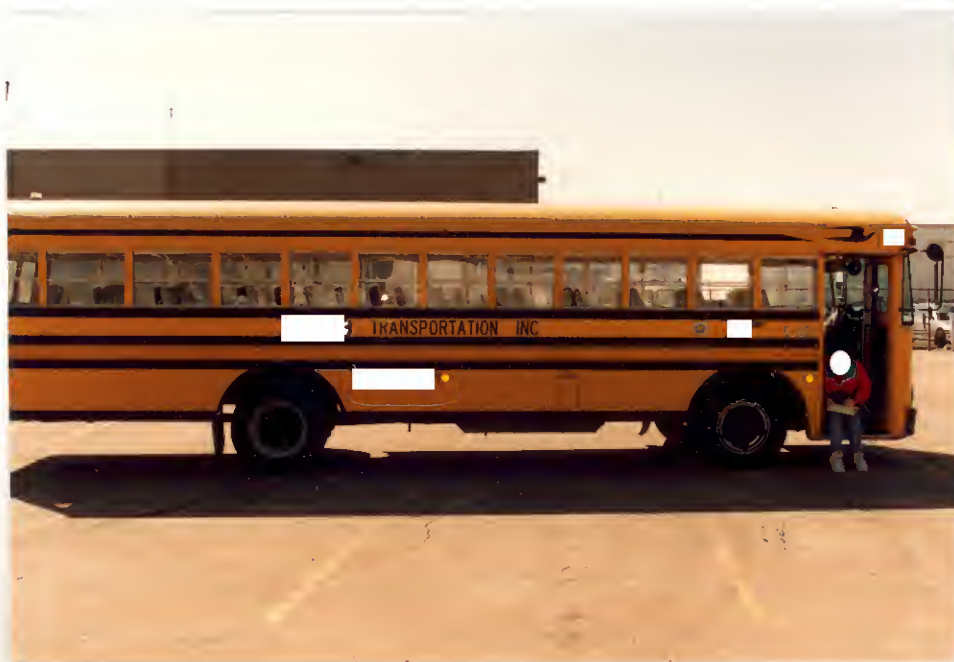
2. Overall view of the right side plane of the School Bus.

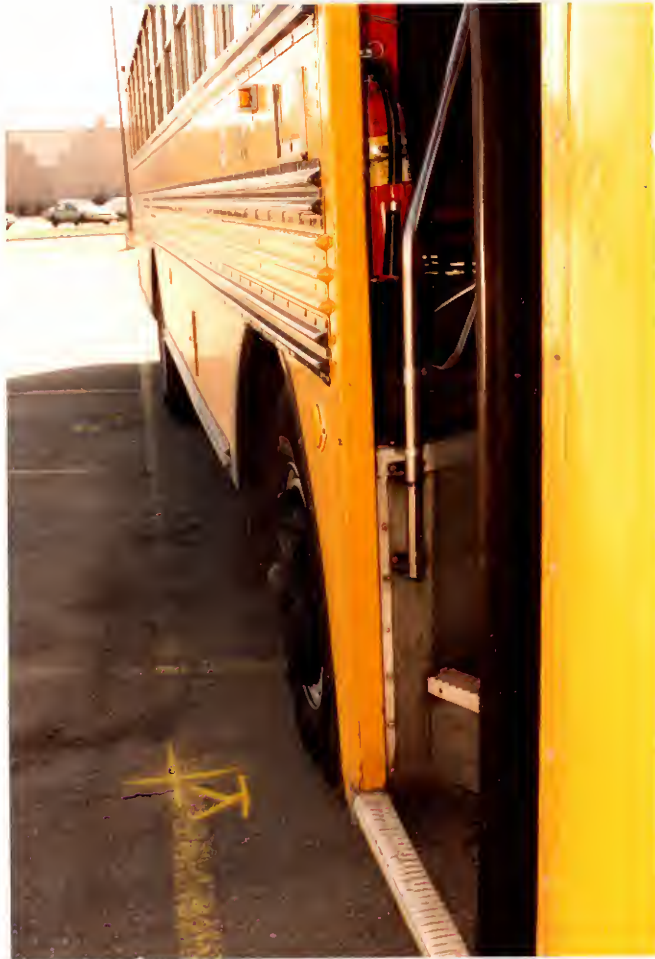
3. Longitudinal view of the right side looking rearward from the leading edge of the egress door.

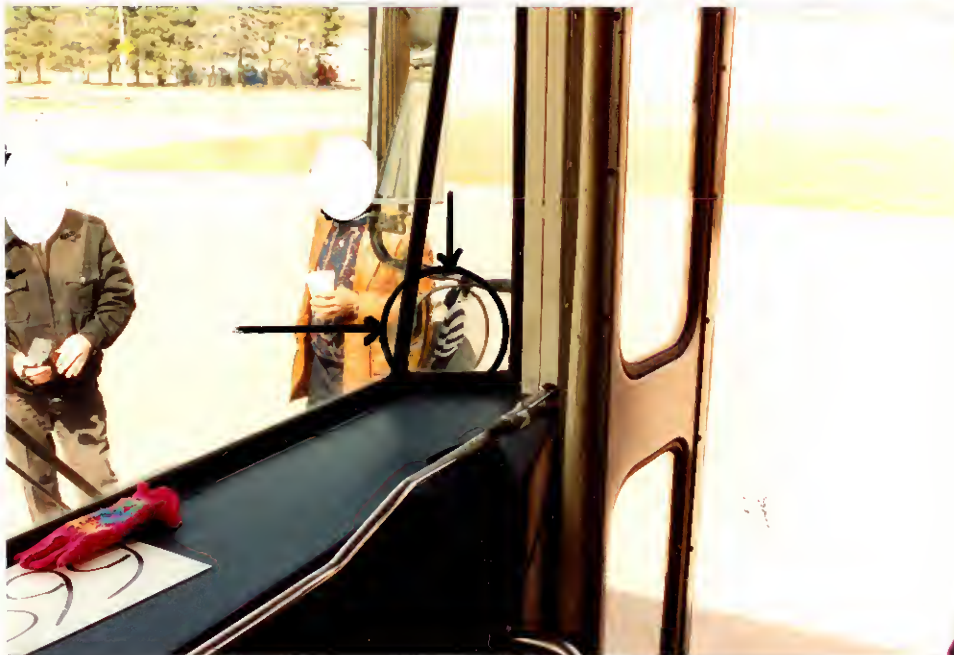
4. Photograph depicts the conspicuity of the pedestrian in the lower convex mirror.

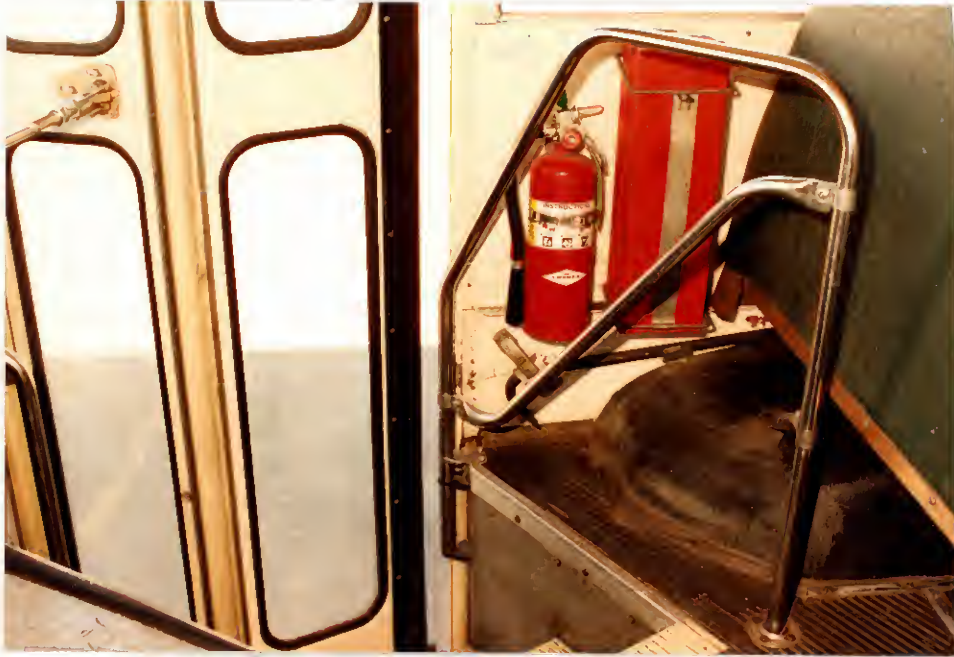
5. View of the handrail system along the right side (rearward side) of the stair well.

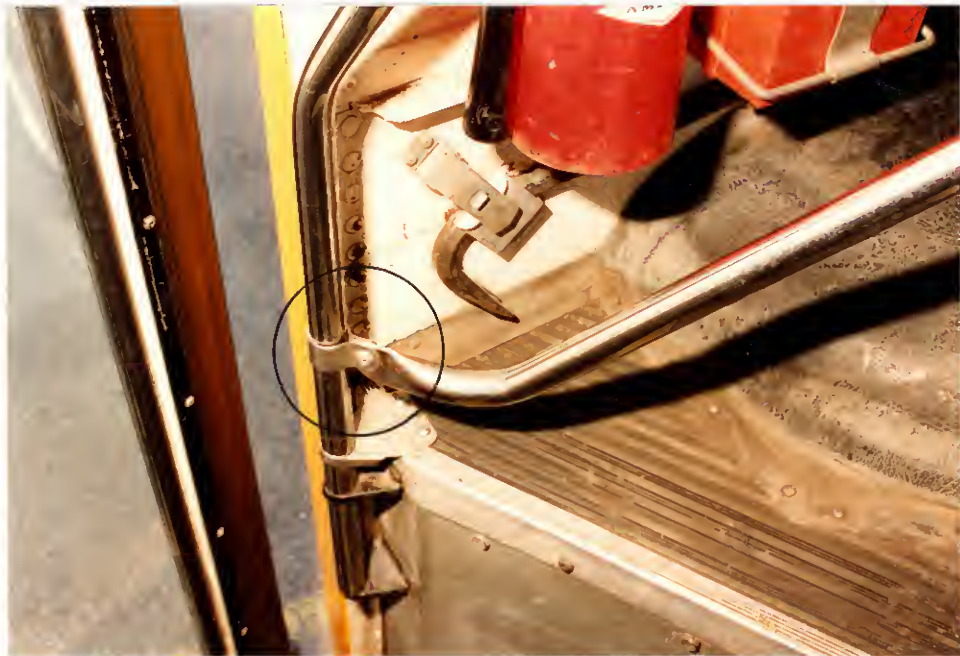
The post-accident modification of the handrail is not a successful remedy to the potential snagging of a drawstring or similar object. During the course of our on-site investigation, we passed a jacket drawstring along the modified hand rail of the involved Blue Bird school bus and the leather tab at the end of the drawstring became snagged at the junction of the handrail and its attachment point with the vertical support. (Refer to preliminary photograph nos. 10-13.) The radius that was ground to the upper and lower surface of the flat end of the rail did not eliminate the void that snagged the drawstring.

6. Closer view of the post event modification to the lower aspect of the replacement handrail showing the attachment bracket with the upper handrail adjacent to the egress door opening.

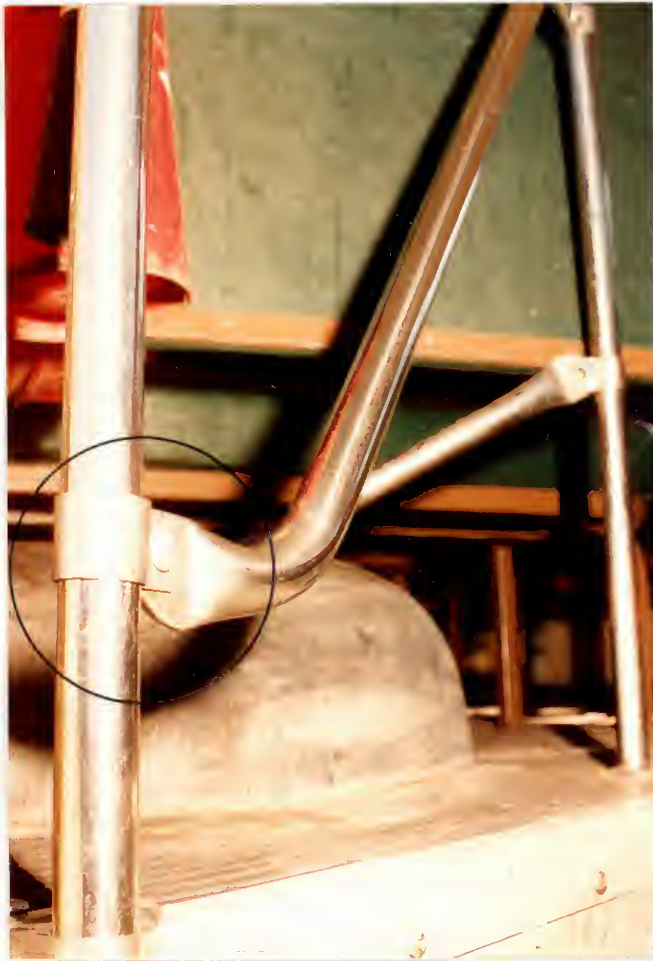
7. View of the post event modification of the lower aspect of the replacement rail at the junction of the attachment bracket looking inward from outside of the School Bus.

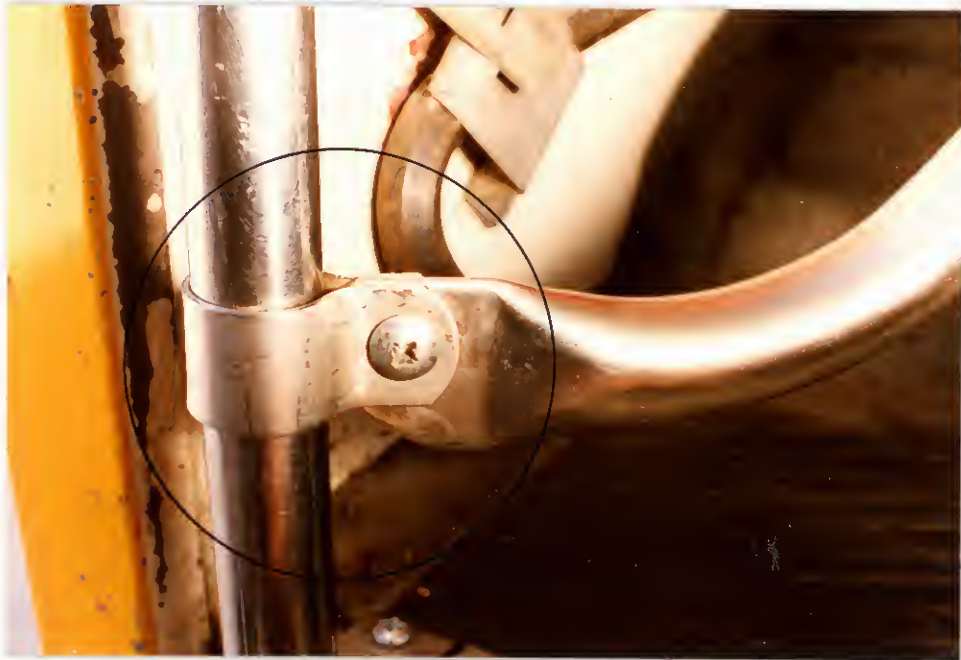
8. Close-up view of the lower rail attachment showing a rounded lower edge which was modified from a square edge after this event.

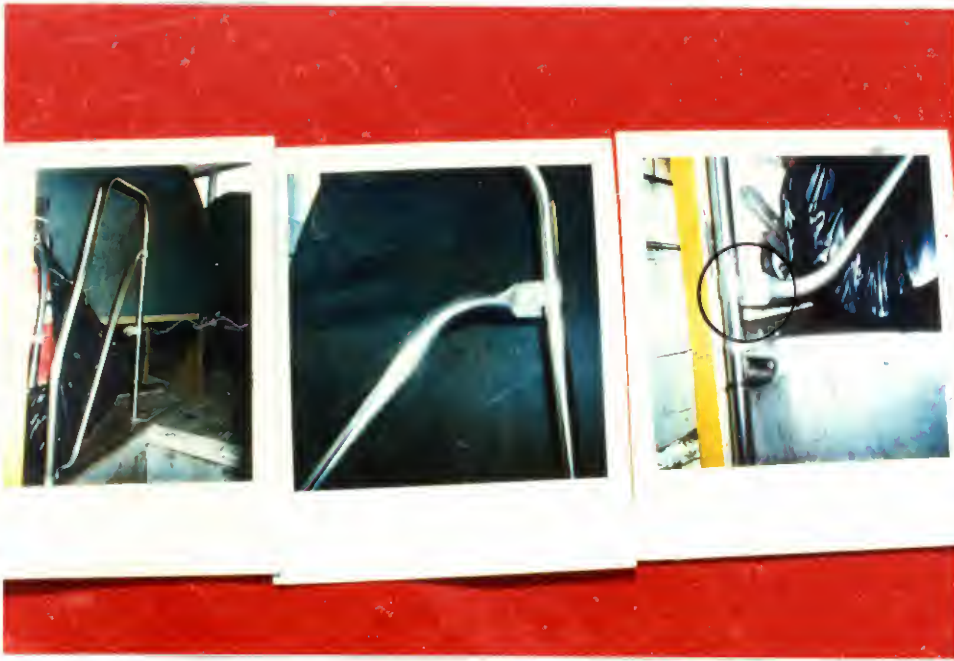
The accident involved three major contributing factors. The first was the handrail which provided a slot between the flat end on the stainless steel rail and the clamp which attached the rail to the vertical support. This slot created a mechanism for the drawstring to become snagged in the hand rail. Secondly, the driver did not provide the pedestrian with sufficient time to clear the bus before closing the door and accelerating from the curb. In addition, she failed to visually track the students as they exited the bus to ensure that they had cleared the vehicle prior to departing from the bus stop. Furthermore, the bus driver failed to check the vehicle's mirrors for pedestrian's prior to accelerating from the bus stop. She did check the right side convex mirror approximately six seconds into the acceleration mode, however, at this point in time, the accident had already occurred.

9. Views of the lower replacement handrail prior to post event modification.

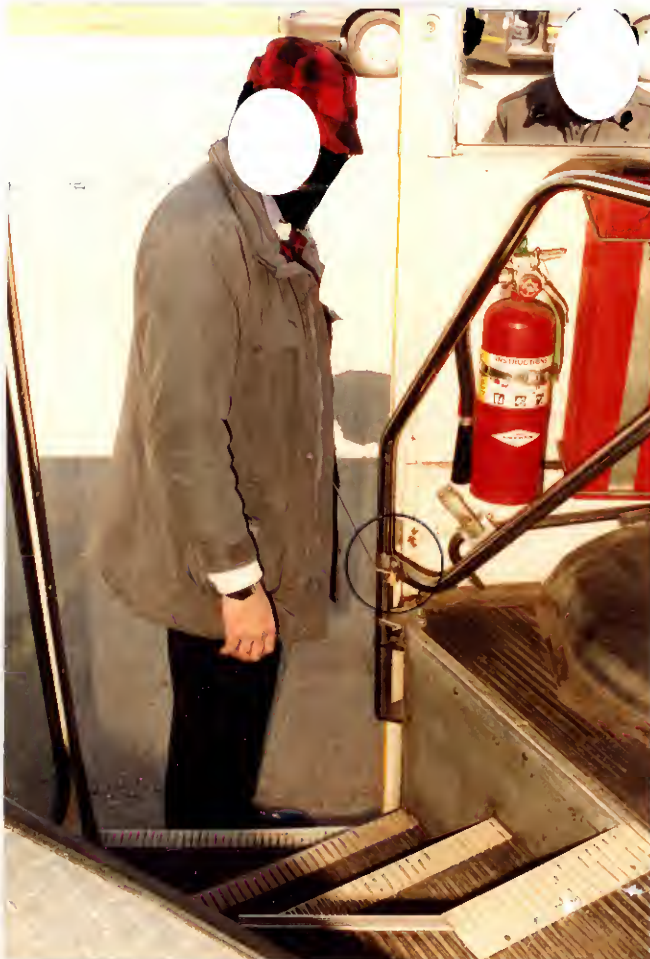
The *Audiocam* system did not record the pedestrian's actions as she descended the steps and exited the school bus. The metallic tab on the right side of her jacket's drawstring became snagged in the slot that was formed between the replacement handrail and the stainless steel clamp that attached the diagonally orientated handrail to the vertical support. This probably occurred as the pedestrian stepped onto the bottom step, or as she was exiting the vehicle. As noted from the videotape, the pedestrian was provided with a scant time interval (approximately 2 seconds) to descend the steps and exit the bus prior to the driver closing the door and accelerating from the curb.

10. Simulation of the drawstring snag in the junction of the lower replacement handrail and attachment bracket.

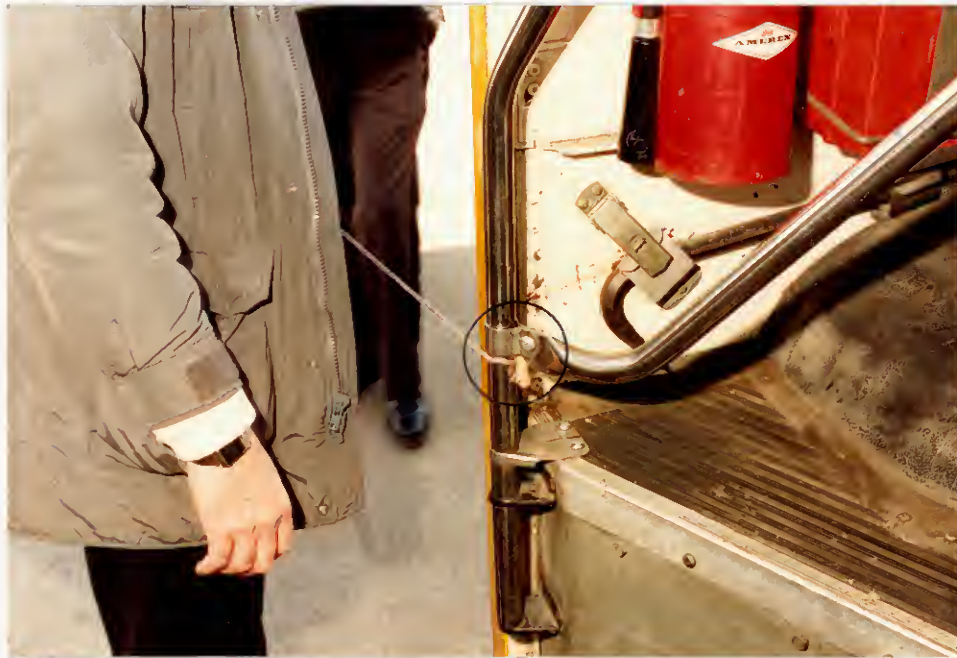
11. Closer view of the simulated drawstring snag in the junction of the lower replacement handrail and attachment bracket.

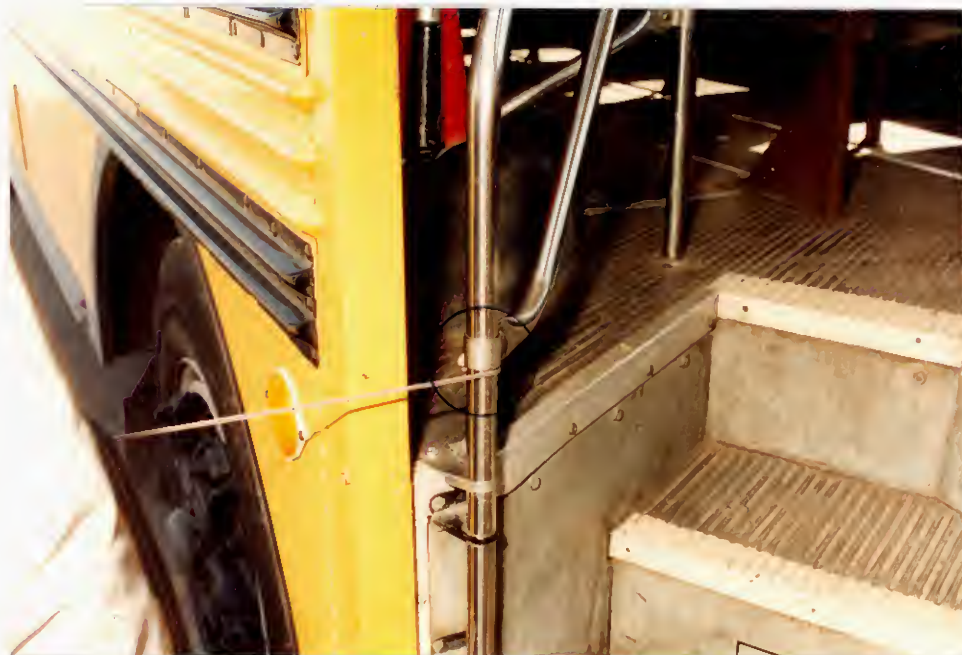
12. View of the simulated drawstring snag from outside of the School Bus.

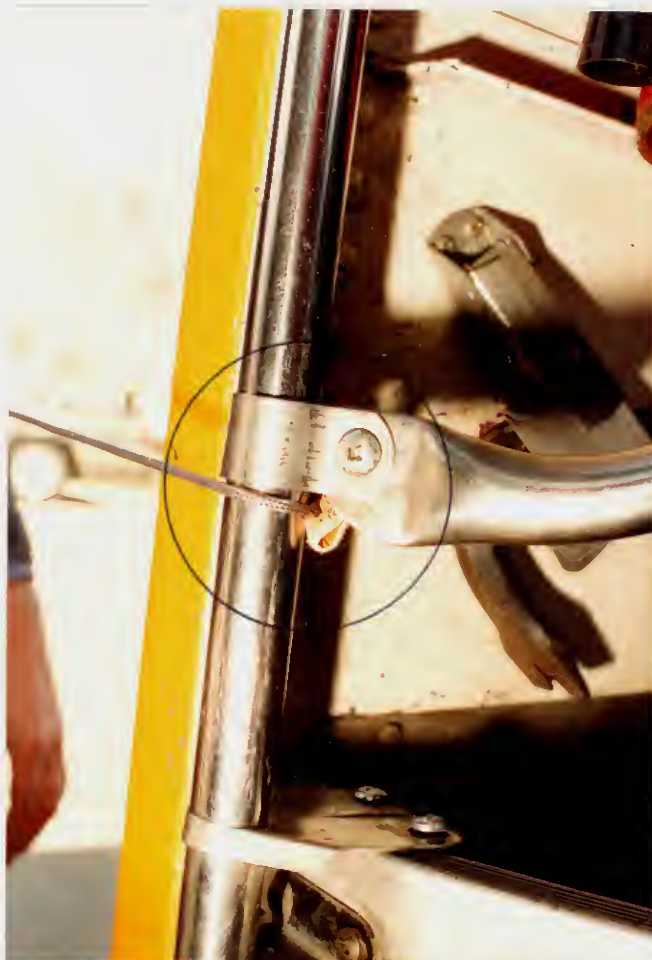
13. Close-up view of the simulated drawstring snag highlighting the leather slack adjuster as the snagging agent.

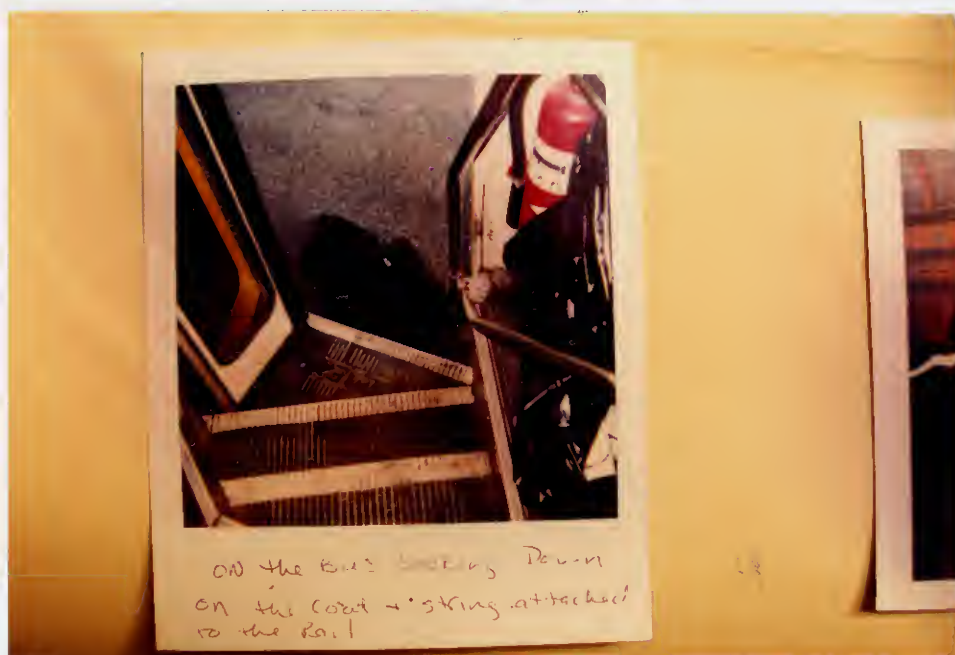
The pedestrian's jacket drawstring remained attached to the handrail of the school bus as the vehicle came to rest. The investigating police officer observed the draw string in the handrail and photographed the engagement at the scene. There was no damage to the drawstring or to the pedestrian's leather jacket.

14. On-scene photograph of the drawstring caught in the junction of the lower replacement handrail and attachment bracket. The pedestrian's coat is located on the ground at the base of the stairs.

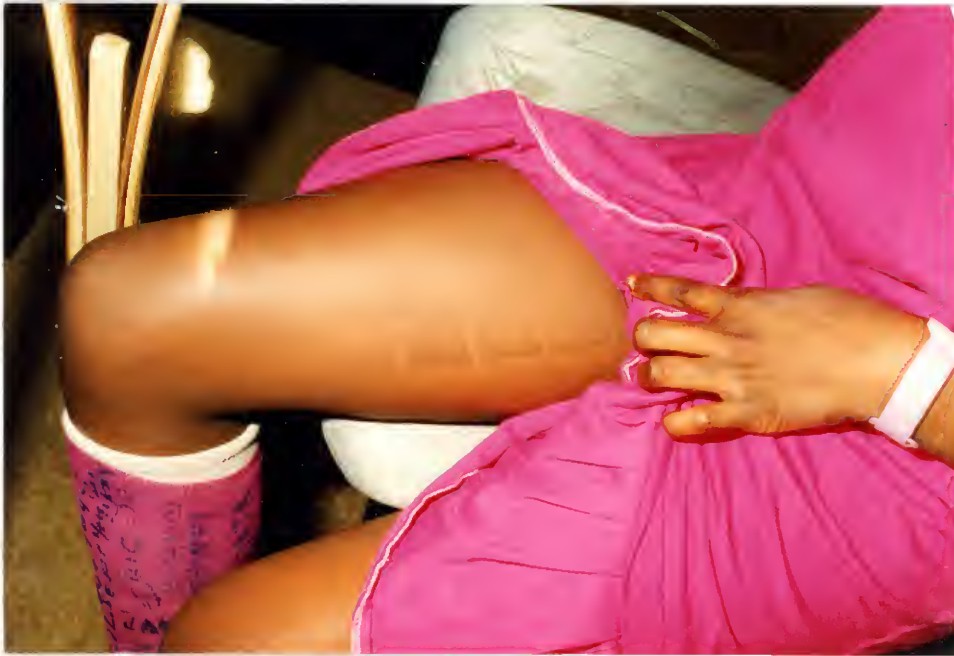
The pedestrian's jacket was subsequently pulled by the accelerating school bus as the drawstring remained snagged in the handrail. The initial acceleration probably rotated the pedestrian in a clockwise direction and into the right side surface of the bus. The pedestrian dropped her book bag as her jacket was pulled off her body. Her mother stated that the jacket was found with the sleeves turned inside out, indicating that the jacket had been forcibly pulled off her body. She probably began to fall to the asphalt road surface and was contacted by the sidewall and edge of the tire tread of the right rear tire. This contact produced a patterned tire tread transfer that was longitudinally orientated on the medial aspect of the right thigh. The contact probably rotated the leg in a clockwise direction with loaded the pedestrian's right ankle resulting in a chip fracture of the ankle. Based on the injury to the ankle, it was possible that the ankle was bearing some of the pedestrian's weight, indicating that she was in an upright, or partially upright orientation when contacted by the tire.

15. View of the pedestrian's right leg showing a tire imprint mark.

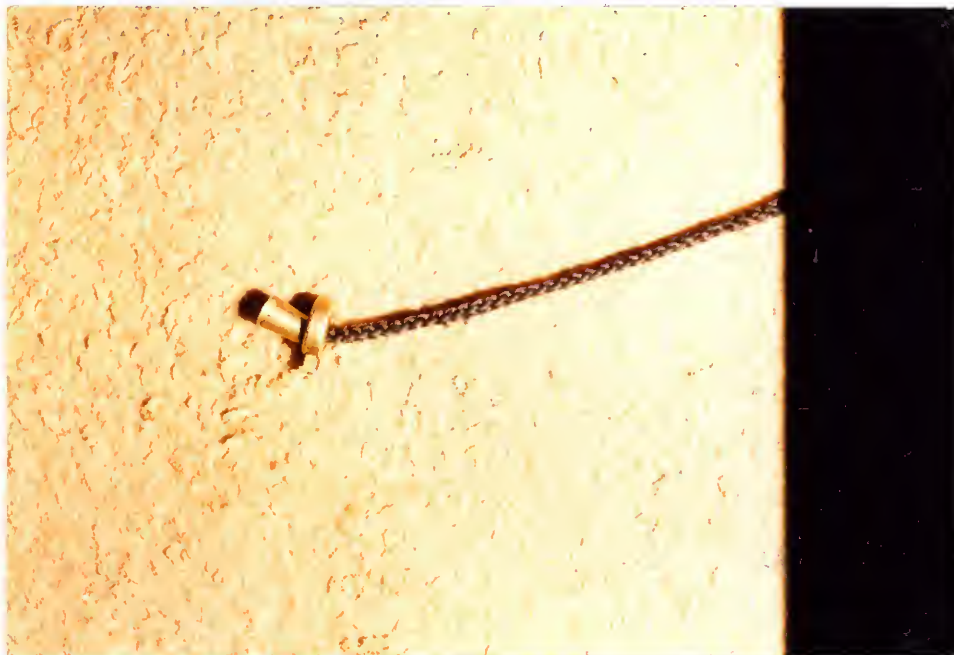
16. View of the pedestrian's drawstring slack adjuster which was caught in the junction of the lower replacement handrail and attachment bracket.
